Short report:

Asbestos measurements during removal of asbestos-containing building materials

Authors: Pål Graff, Torunn Kringlen Ervik, Stine Eriksen Hammer, Jon Hovik, Ole Synnes, Nils Petter Skaugset

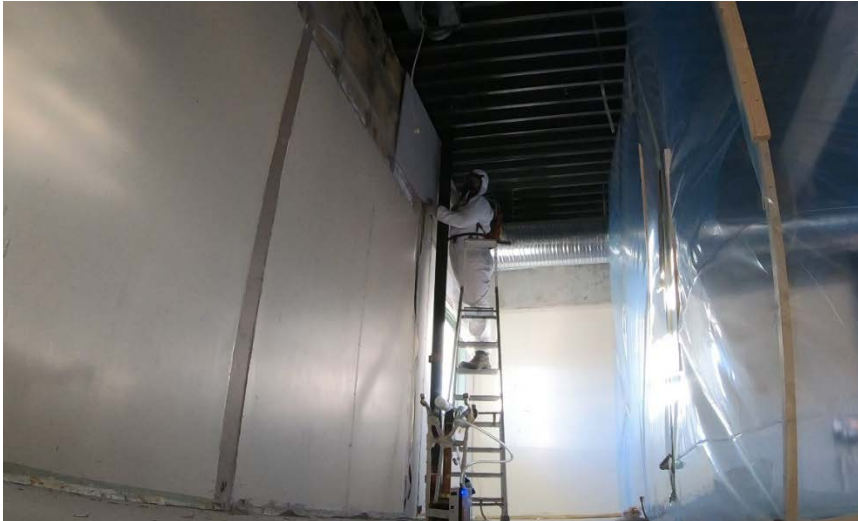
Figure 3.1: Removal of indoor asbestolux wall plates

Interior wall plates and ceiling plates, such as asbestolux, is often brittle and contain large amounts of amosite. The removal of indoor walls was done carefully to reduce the spread of fibres. Still, relatively high fibre concentrations were measured in the air when sanitising this type of material, and more than 90 % were amphibolic fibres and mainly amosite. Fibre counts from the personal sampling during indoor asbestolux removal are shown in Table 3.1.

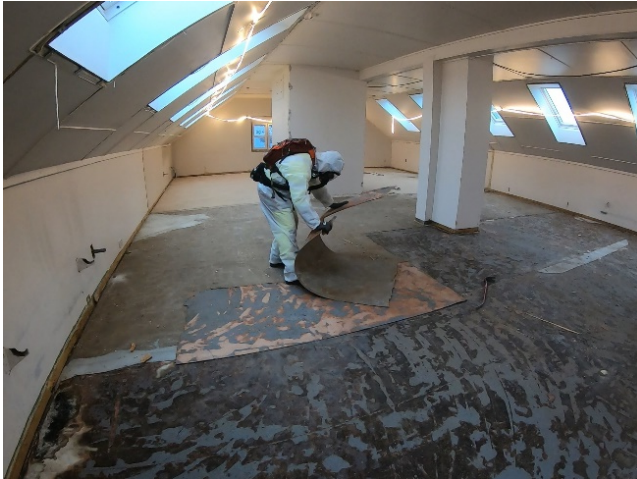
Figur 3.2: Removal of asbestos containing floor.

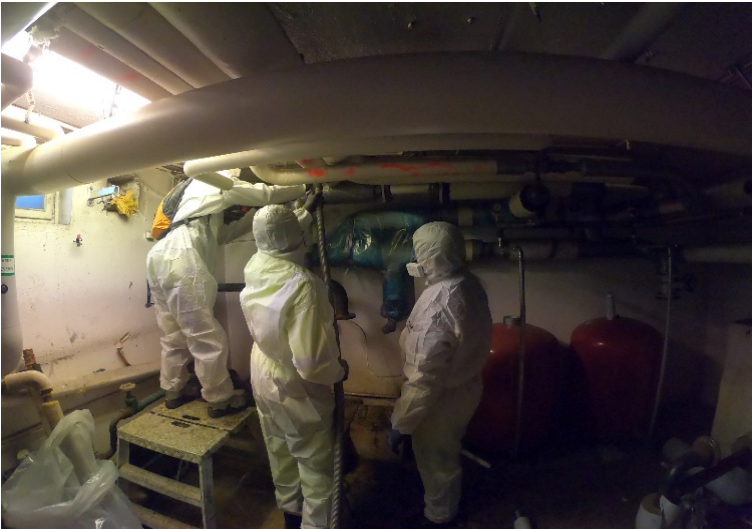
Figure 3.5: Removal of a pipe section with asbestos insulation.

The pipe section, if containing asbestos, is wrapped in plastic before being removed as a whole piece, without covering the whole room as is done in other indoor asbestos removals.

For pipe asbestos removal, it is assumed that asbestos fibres are not released since the pipe section in question is wrapped in plastic before dismantling. Air sampling conducted during this work still showed 0.1 asbestos fibres, when counted with PCM. However, an asbestos fibre concentration of 0.02 fibre/cm³ was determined by SEM. Other fibre types, such as gypsum, were found and might explain discrepancy between PCM and SEM.

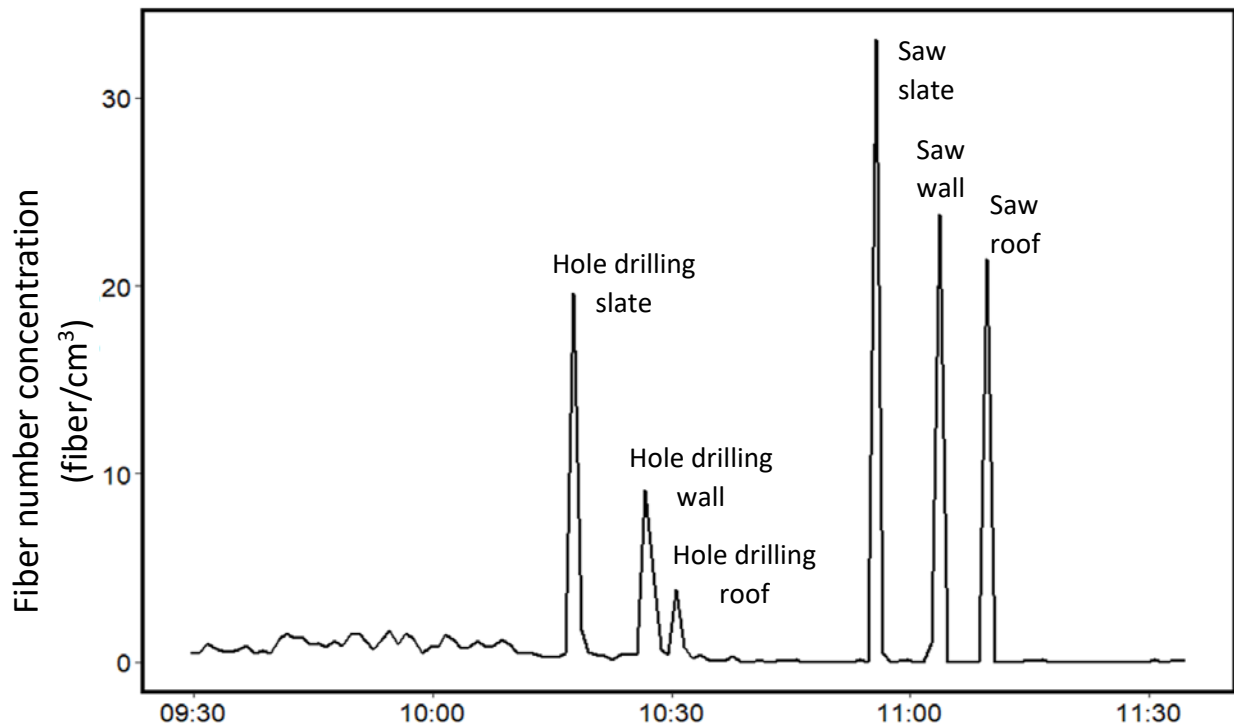
Figure 4,1: Fiber concentration measured with a real-time fiber monitor (TSI) during short-term work.

During the project, measurements of asbestos fibres were done during drilling and sawing in asbestos-containing building materials (Figure 4.1). This was done to investigate the exposure during minor work tasks such as drilling a hole in the outer wall. These operations are short, but a craftsman may have to perform many such short-term operations on asbestos-containing materials.

Drilling in the ceiling and wall seemed to generate more dust on the filters than sawing. The A significant amount of fibre is released during these operations. Even if the work is performed only for a short time, the sum of such short-term work operations over a long working life will lead to significant exposure to asbestos fibres.
